Manhole Inspection Summary

Manhole # S31OO1002MH

Insp Date: **4/14/07 9:55 AM**

Location Address: **4501 CHARLES ST**

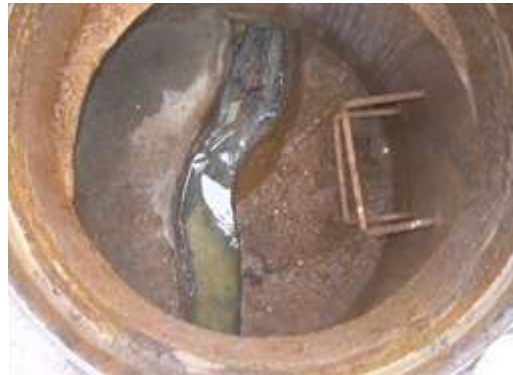
Top View

☐ Parged ☒ **Debris** (not Condition related)

Bench debris.

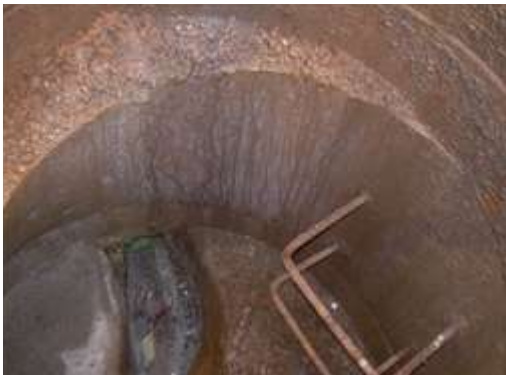
Defect

Offset: **2** (in.)

Condition: ☐ Sound ☐ Cracked ☒ **Leaks**

Infiltration: ☐ None ☒ **Joint** ☐ Cracks ☐ Mortar ☐ Roots ☒ **Wall**

Frame leaks. Frame offset. Corbel infiltration.

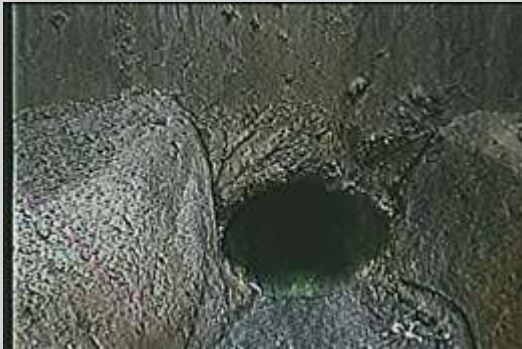
8 in. Circular Gravity Sewer Pipe Out @ 12 O'Clock

Infiltration: **None** Pipe Seal Cond: **Unknown**

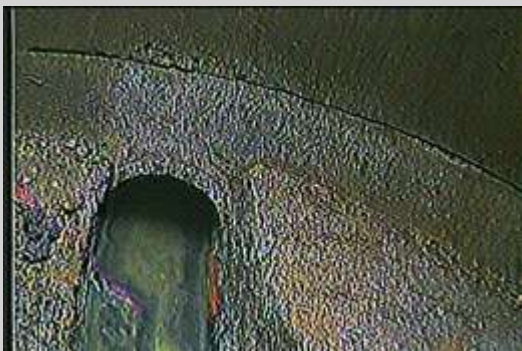
8 in. Circular Gravity Sewer Pipe In @ 6 O'Clock

Infiltration: **None** Pipe Seal Cond: **Unknown**
